Statue on exit road from Mt St Mary's Academy, Watchung, NJ

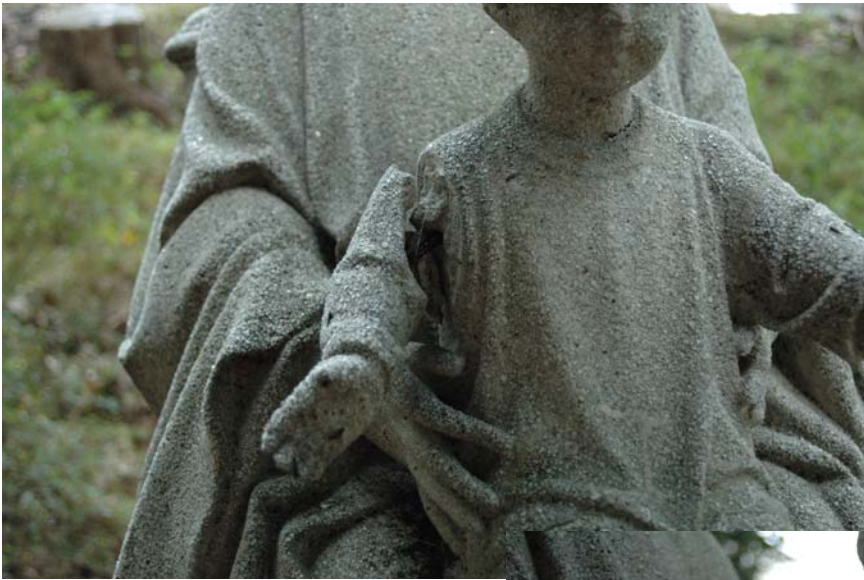
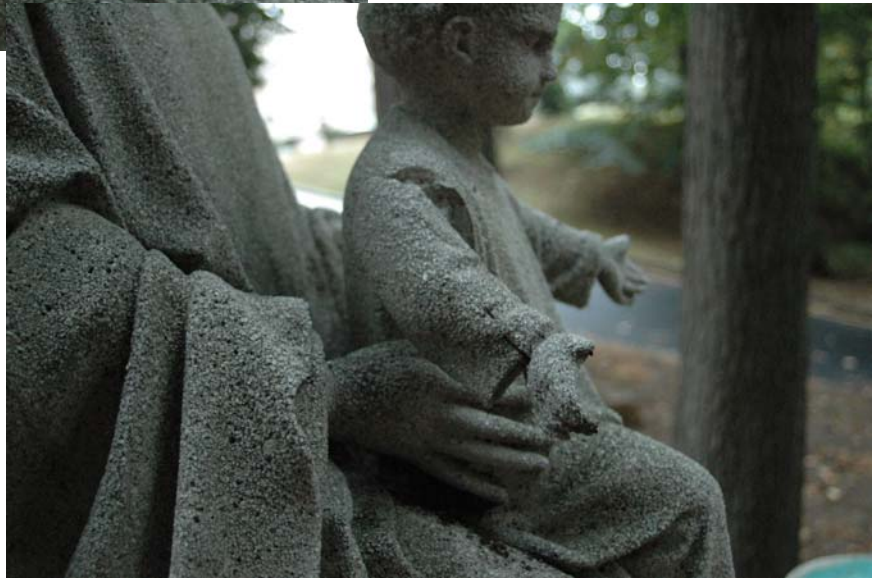
On first examination it was determined that the break was actually a failed repair. Remnants of the repair material were obviously of a composition other than that of the rest of the piece. Fortunately, the armature was intact and so it was possible to realign the parts and proceed with the repair.

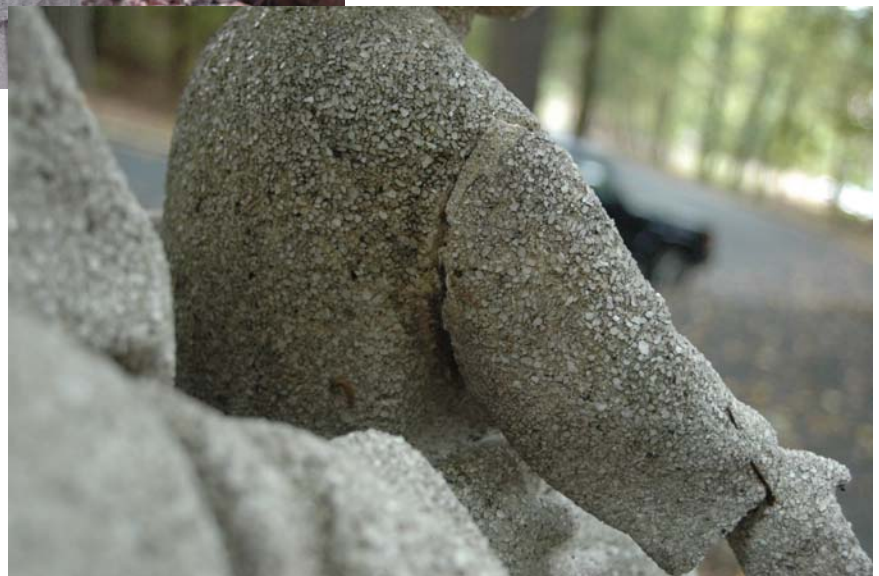
Two days later, the Grund had achieved a sound cure. The bindings could be removed, and the parts are here seen in true alignment.

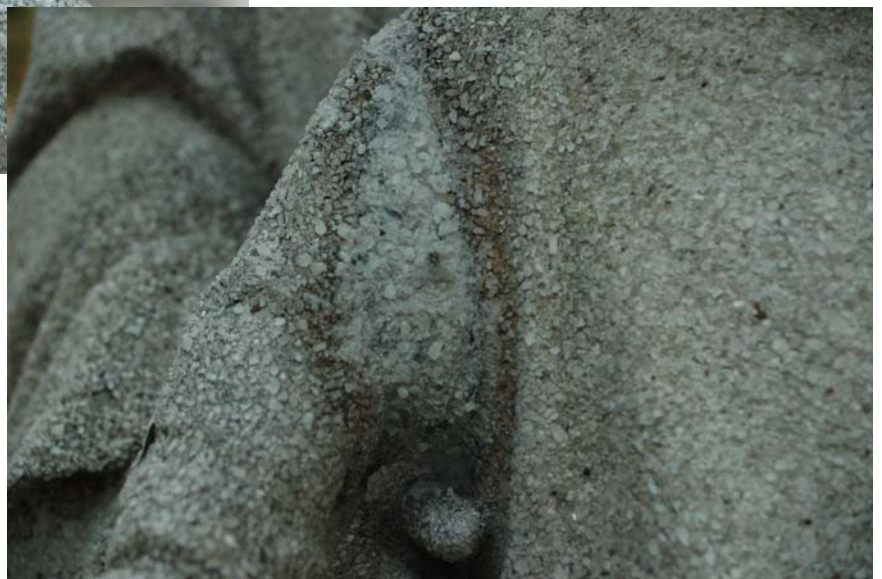
These last two photos show a first attempt at tinting the fill to match the surrounding material.

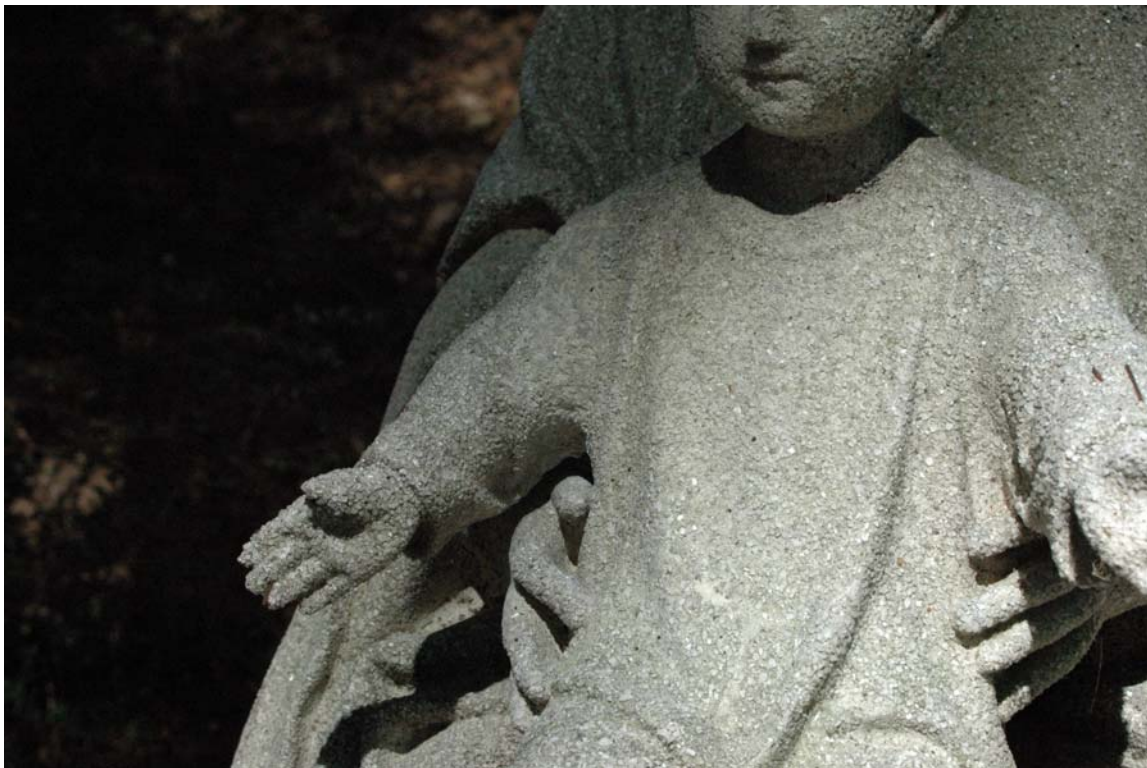
On returning to the site for final touching, it was found that the changed topography of the restored area, with a different drainage pattern, had encouraged resumption of the original coloration of the material surrounding the repair. The finished repair had effectively blended with the original material.
