Lagoon Balustrade Preliminary Assessment

Repair Process
West Balustrade
Sunken Garden
Summer 2003

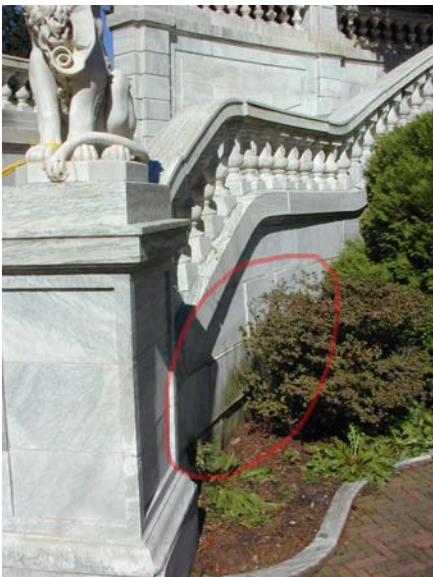
A shifting of the blocks outlined in red, to the left, has caused a pronounced list in the balustrade, shown at right. This list has reached a degree where it was determined a hazard to public safety, and the staircase closed to traffic.

Repairs in this case will likely require disassembly of the balustrade, and the inside retaining wall, before reaching a point where the cause of damage becomes evident, can be alleviated, and reassembly accomplished. It is possible that some below grade work will also be necessary.

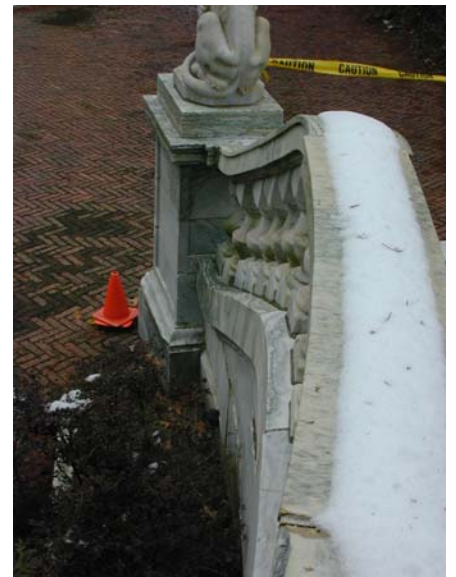
The width of the caulk joint between the risers and the lower rail of the balustrade is further evidence of this movement.

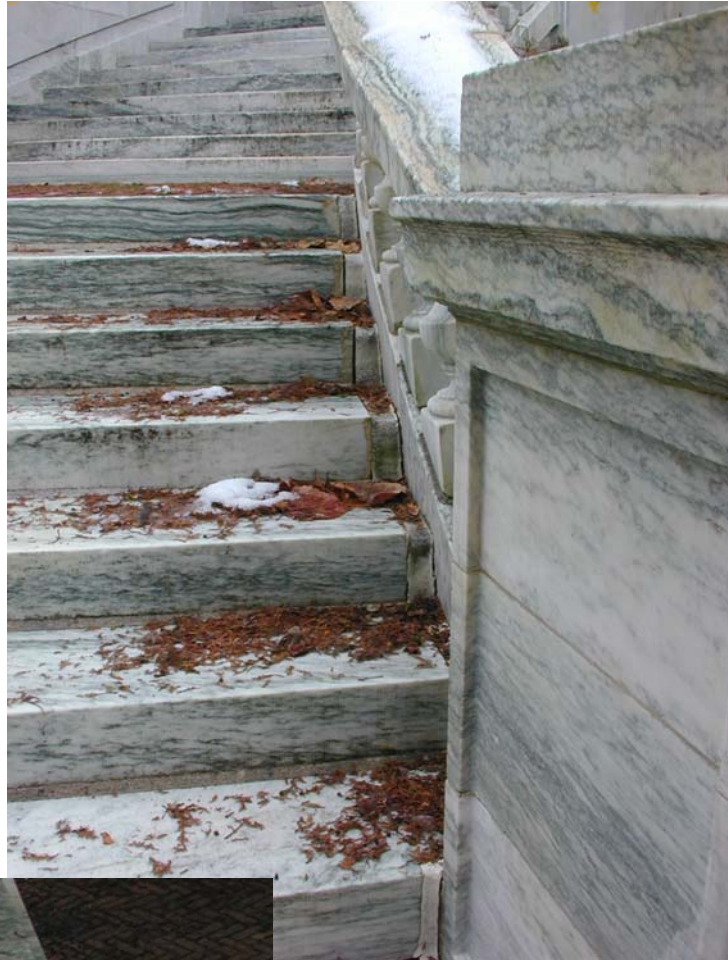
The displacement of the upper rail is clearly illustrated in the photo, at left.

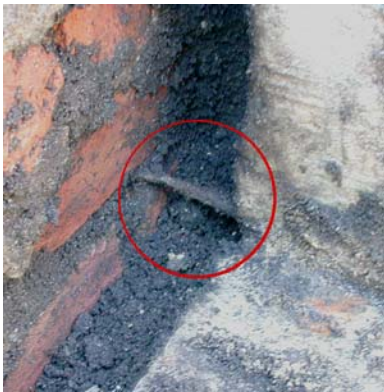
Circled, in the photo, at left, the one installed original wall tie.
