Porte Cochere

The morning of Jan 6th, 2003, it was noticed that the porte cochere at the main entrance to the mansion had been struck once again, and that this end section with the two columns it supports had been shifted further out of position.

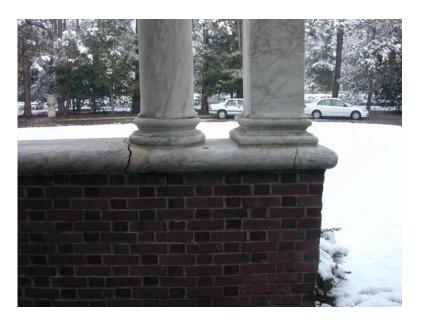
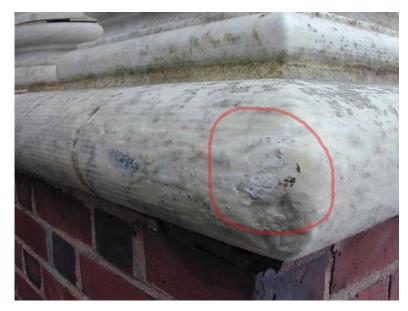
Outlined here in red, fresh paint and bright metal indicate the point of impact.

To the right, we see clear evidence of the shift, nearly an inch of freshly exposed material.

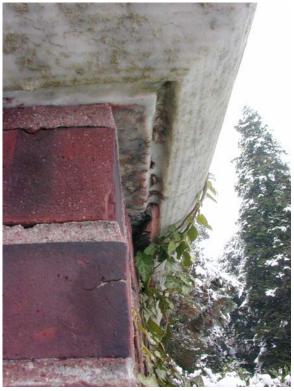
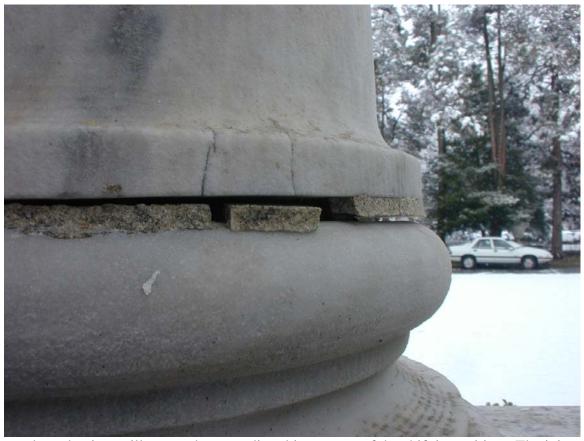
The photo above begins to illustrate the most disturbing aspect of the shift in position. The joint between the base and the column has opened up considerably.

The photo to the right, presenting the opposite side of the column, shows the results of having the entire weight of the structure rest on a single point instead of shared out across the entire face of the base.

It will not be possible to realign the break without disassembling the columns, however, the old mortar will be removed prior to moving the marbles, and the gap will close somewhat in the process.

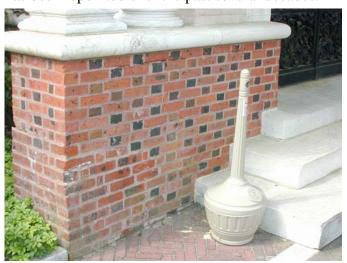
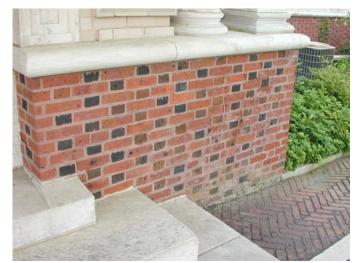
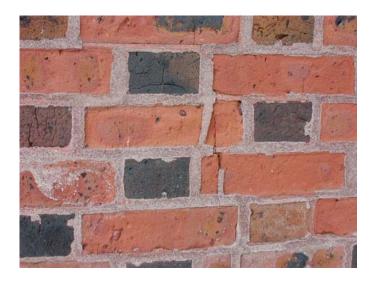
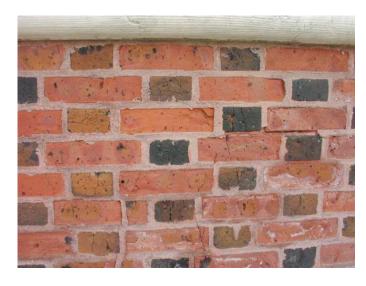
Part of the installation, but not related to the accident, the brickwork flanking the main entrance, is showing the same symptoms, and requires the same treatment, as the rest of the masonry that has been repointed over the past several decades.

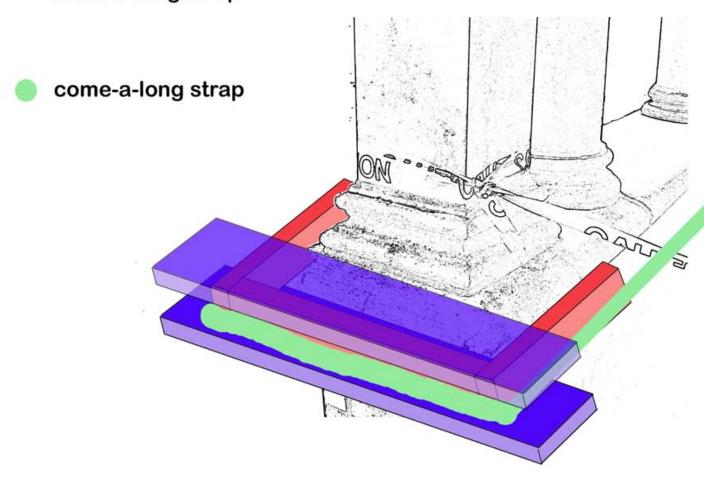
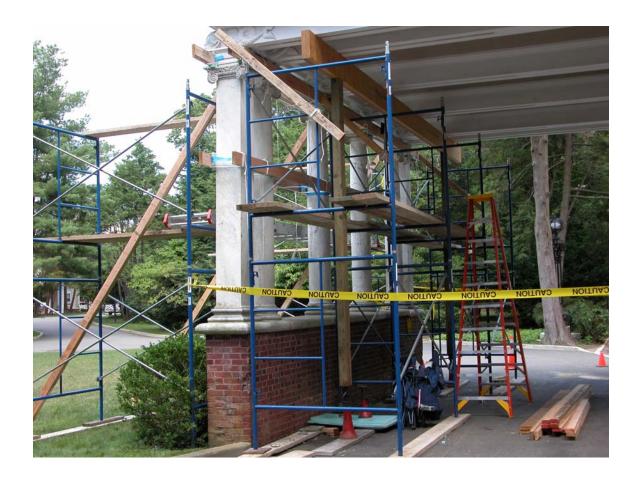
2X construct protecting marble and providing guide for come-a-long strap

The only significant changes made from the drawn plan were to move the mount for the jacks from the upper deck of the scaffold, to the ground, and the addition of scaffolding outside. The operation was a success.
