Bond Baluster Mold

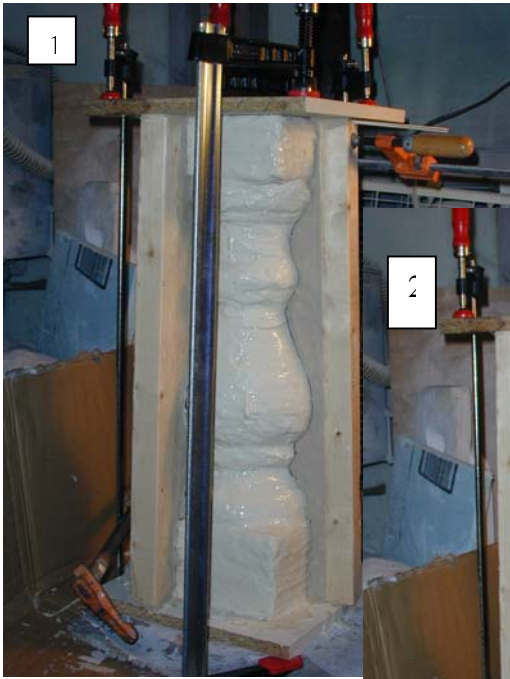
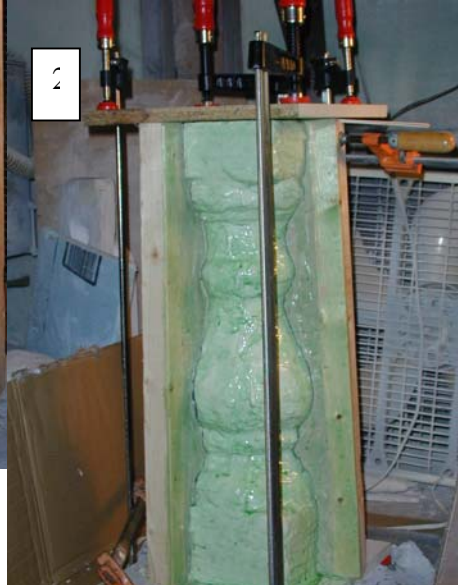
I originally thought to repair the damaged pieces but found the stone to be so badly rotted inside the plaster sheaths that that was not a realistic approach. I found a vendor at the 2006 Traditional Building Show in Washington, that I thought was going to do the work for me, but that didn't work out. So, here's the repaired column 1) encased in Smooth-On 40, 2) painted in PVA prepped for a fiberglass mother, 3) glassed, 4) and opened.

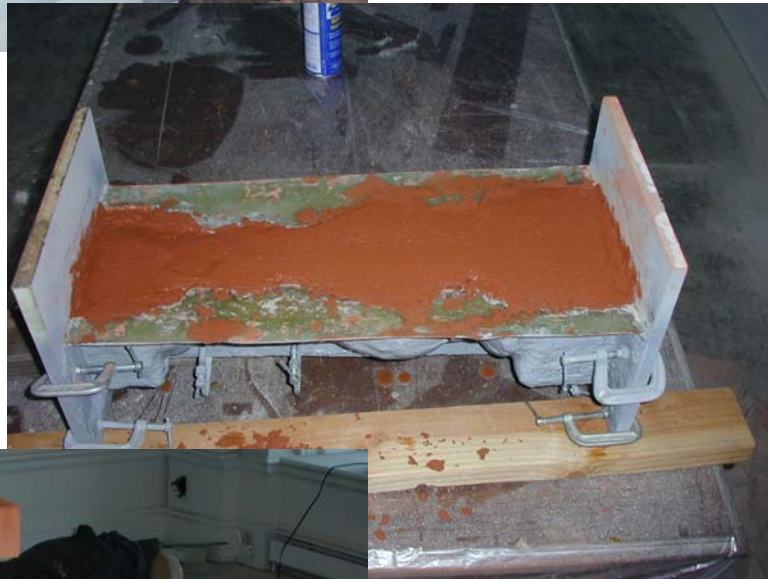
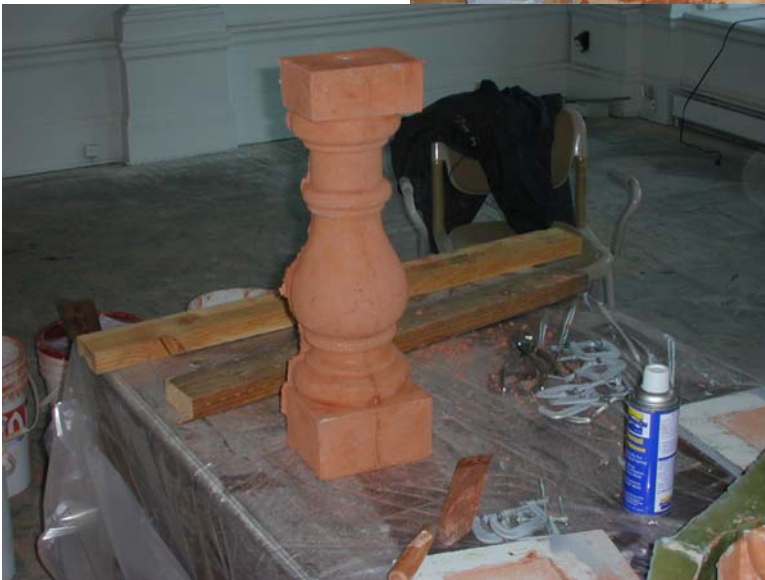
I made the mold in the studio and ran the production on-site. We used the mortar that all stone repair on the job was done with to fill the mold. A piece of 1/2" plated rod was painted with a cold galvanizing treatment and suspended in the center of the mold as reinforcing.

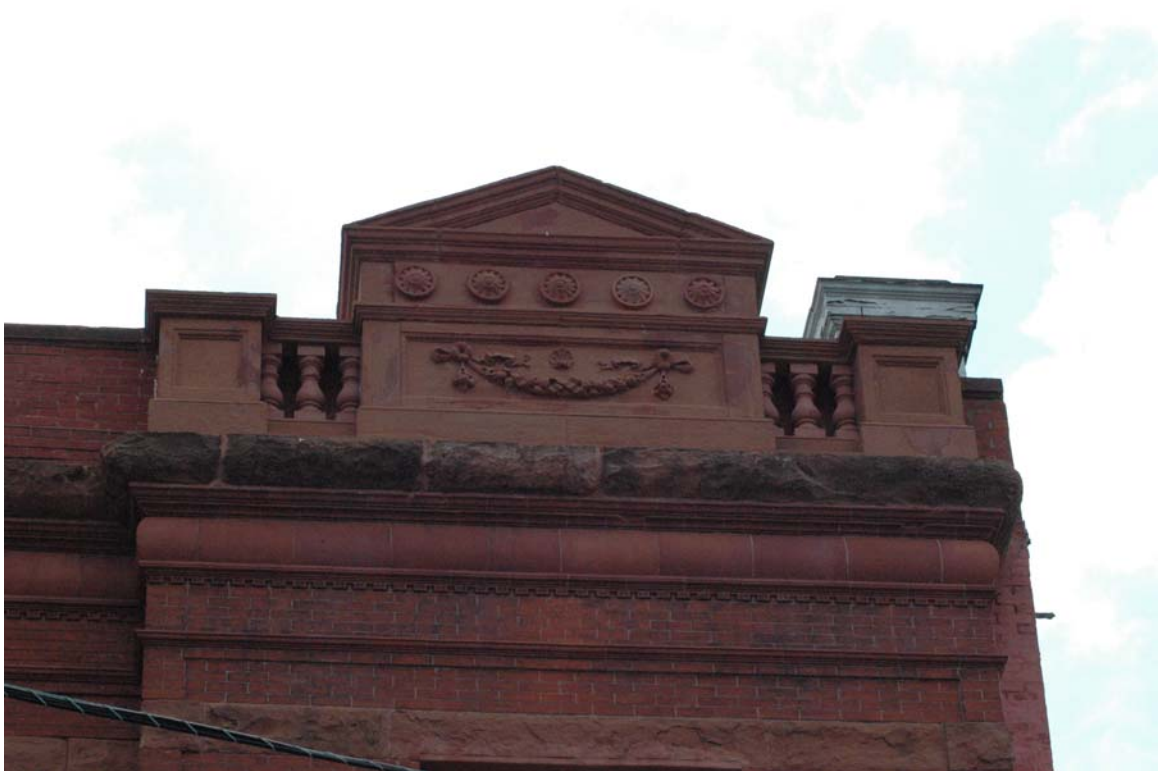
All eighteen balusters were replaced in this way. The second round emblem from the right is the first of the terra cotta replacements to be mounted.
