Terra Cotta Garland South Pediment

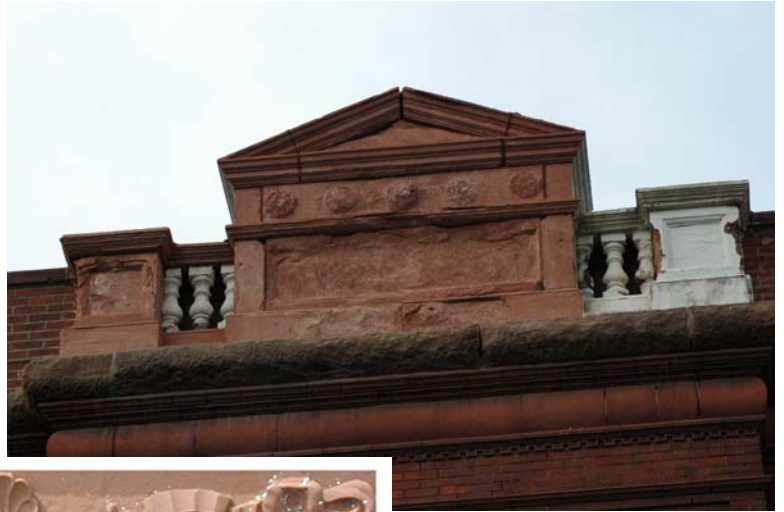
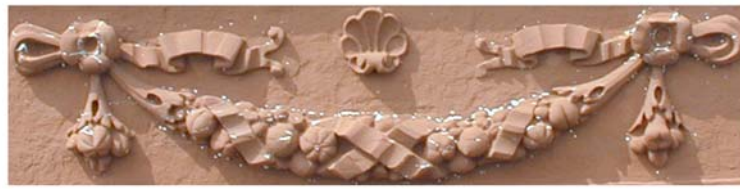
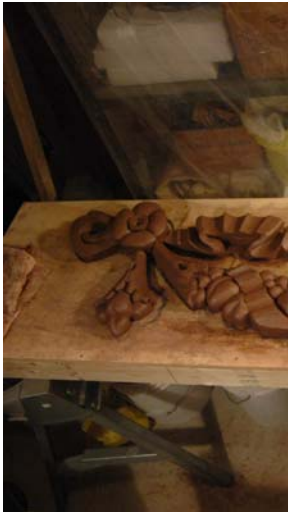
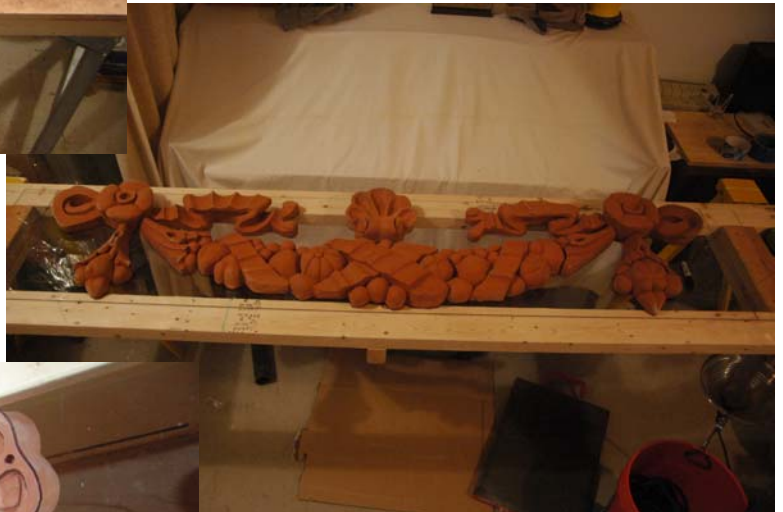
The south-facing pediment exhibits the very worst of the stone decay found at this site. Using the panel from the northeast as a guide I produced a similar design in terra cotta, shown here in raw and fired states.

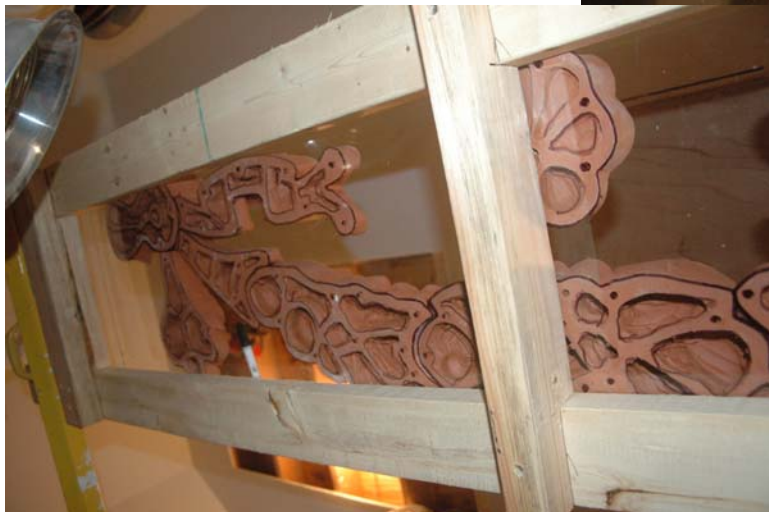
This photo was shot from below while mapping the drill pattern for the stainless anchor pins. The work is composed of twelve separate pieces to facilitate transport and installation.
