Lagoon Balustrade Preliminary Assessment

Repair Process
West Balustrade
Sunken Garden
Summer 2003

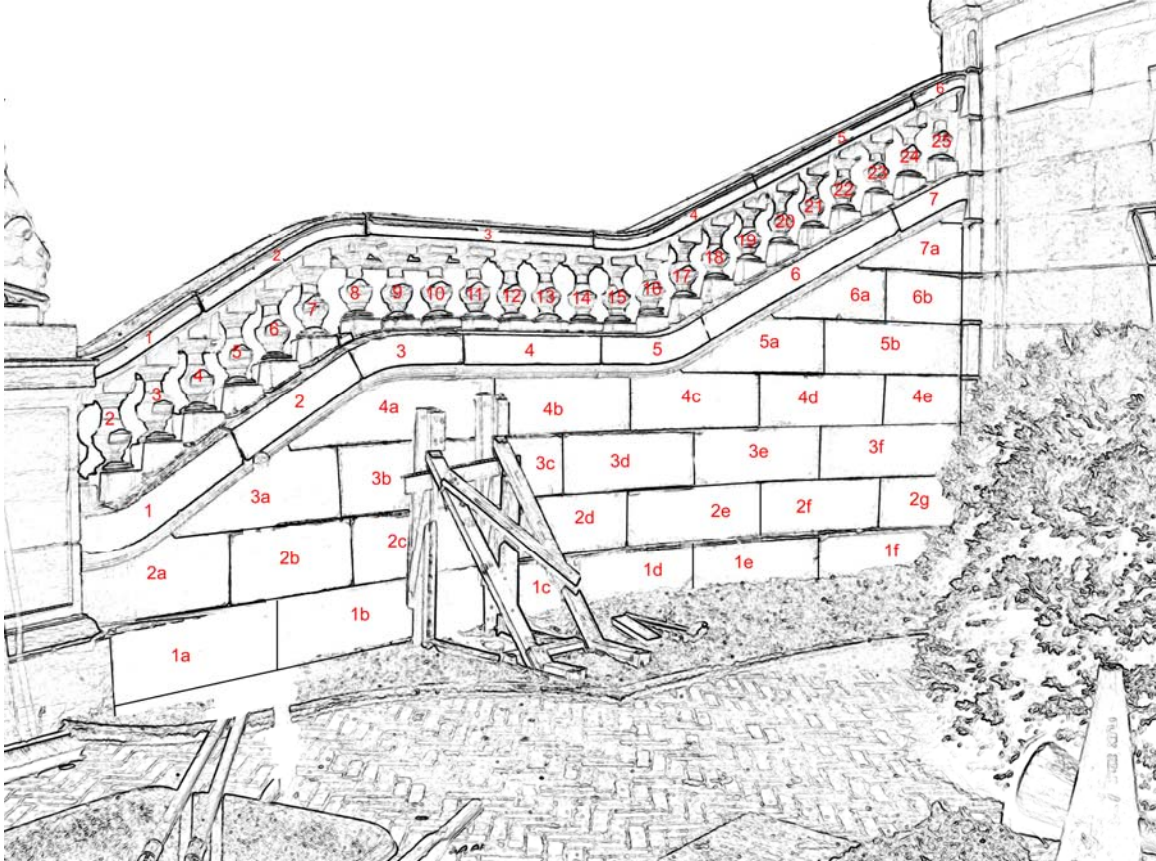
The first steps in the repair process entail the marking of each piece in the installation and mapping of their placement. The most severely buckled section of wall has been shored to protect against the danger of collapse as the upper sections are dismantled.

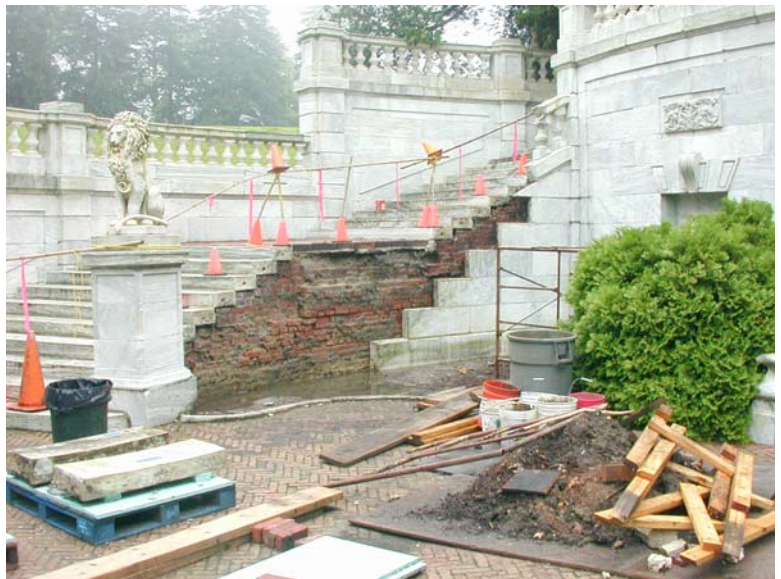
Fortunately, displacement of the wall did not extend beyond those stones locked in place by elements of the main façade. With stones removed, as shown to the right, all sediments and debris removed from the cavity between core and façade, we moved on to preparation for reinstallation.

Before resetting each stone had to be cleansed of old mortars still adhering to the bond surfaces, and, as much as possible, mortars bonded to the face. As noted earlier, the bedding mortars had deteriorated to the point where a stiff brush was sufficient to provide an acceptable result, in most cases. The material left from previous repointing efforts presented the major difficulty. Soiling and biological growth was removed through an application of GranQuartz 515C Periodic Intensive Cleaner.

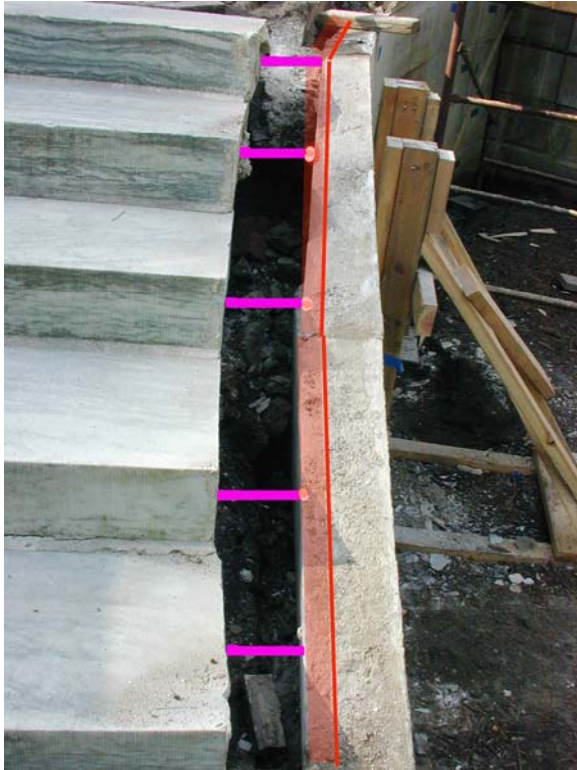
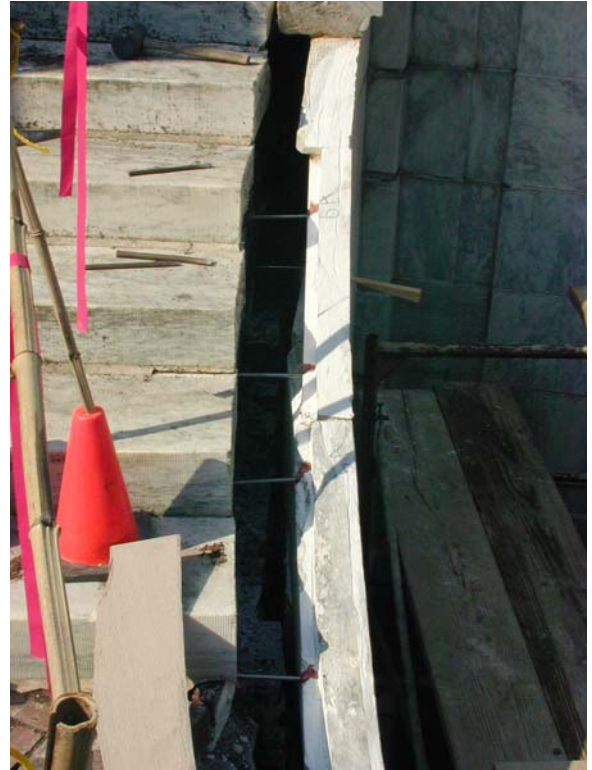
At this point we make our only major departure from the original design. As stated earlier, when dismantling the structure we discovered a cavity filled with soil and masonry debris. The copingstones are considerably wider than the façade blocks and in most places had less than a 50% bearing on the lower construction. It is very possible that the original masons purposely added this fill hoping to support the coping while the mortars set. If so the concept worked, initially. However, such a fill would hold moisture and in a freeze would exert an expansive force sufficient to displace the façade blocks. A slight movement would open the joints between the façade and the risers. In a thaw, the fill would soften and settle into the additional space left by the movement during freeze/expansion. Later rains would wash additional sediments into the open joints caused by the initial movement, beginning a cycle that could very likely have caused the eventual condition of near collapse. The fact that almost none of the intended anchors were installed certainly contributed to this progression. In order to cope with the situation, the following innovation was incorporated into the structure.

Hoping to keep the cavity open, facilitating drainage and aeration, it was decided to span the void between the top façade stone and the riser core structure with a concrete deck. Distributing the burden of the upper structures evenly amongst the separate lower constructs, provided a sound base for the copingstones without creating stresses that would encourage lateral movement. At left find the final detail for the concept.

The photos below show projected and actual implementation.

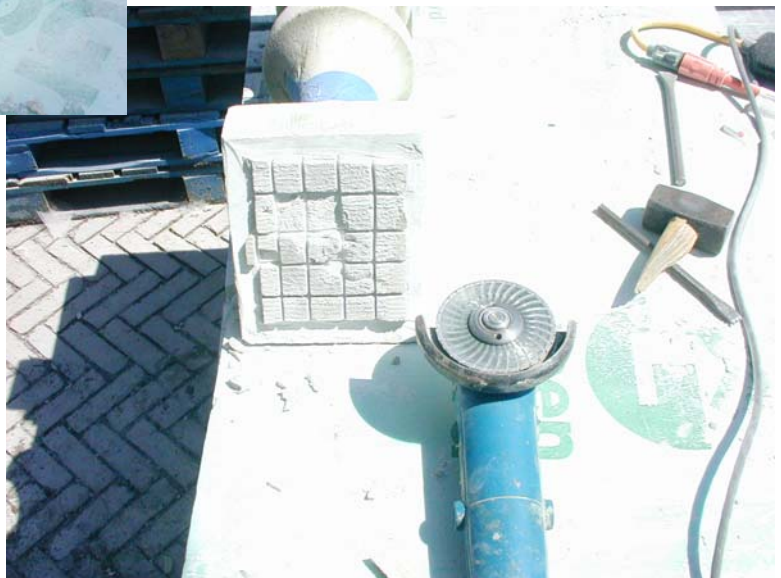
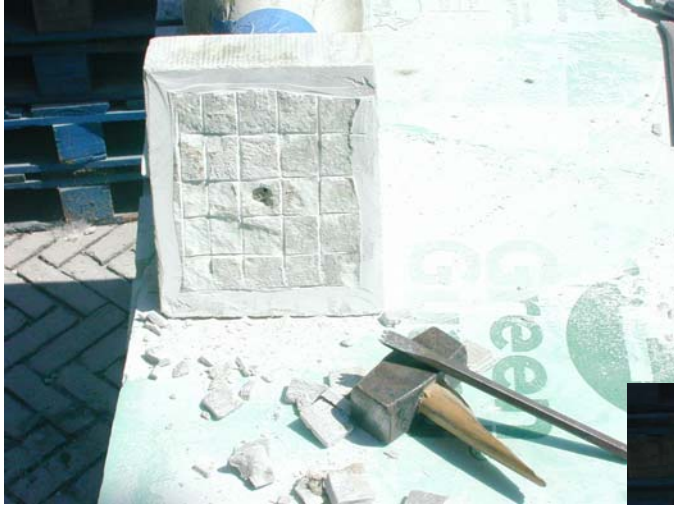
With setting of the copingstones the base structure was complete and we moved on to preparation of the balusters and rail. As can be seen at right, the material used to set the balusters was of an extremely tenacious bond. So much so that in dismantling, often the marble gave before the mortar. Before reassembly, the bonding surface of the stones had to be cleansed

In order to protect the vulnerable edges of the stone the old mortar was cut back using a four-inch diamond blade in a hand held grinder. Scoring of the mortar into a grid pattern allowed use of hammer and chisel to clear the bulk of the offensive material.

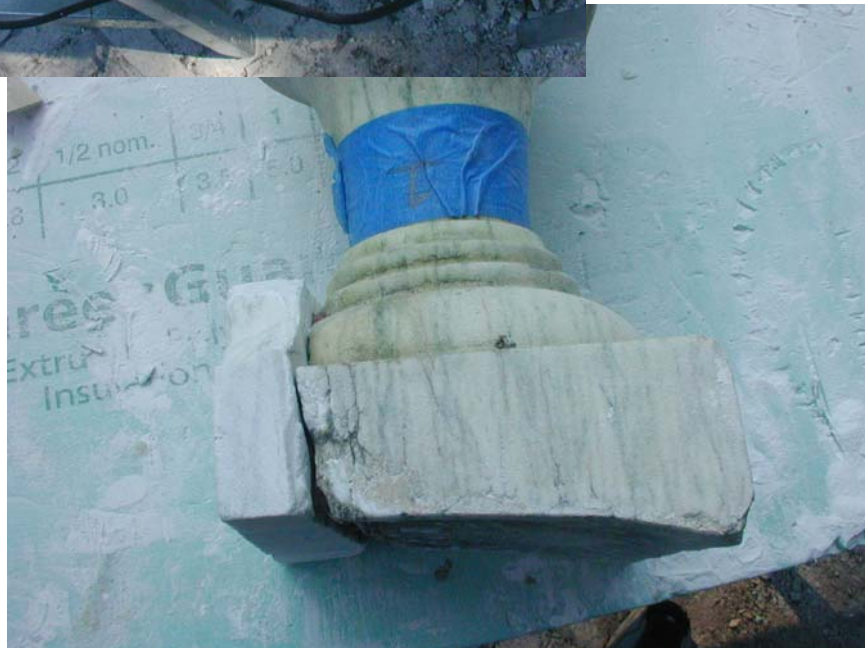
The photo at right shows the condition of the #1 baluster as we approached the job. Broken sometime in the past, the shards are unavailable, and replacements must be fabricated.

As documented in the previous operation, the stones are marked and drilled to accept stainless pins, that are anchored in Hilti epoxy, and left to cure overnight.

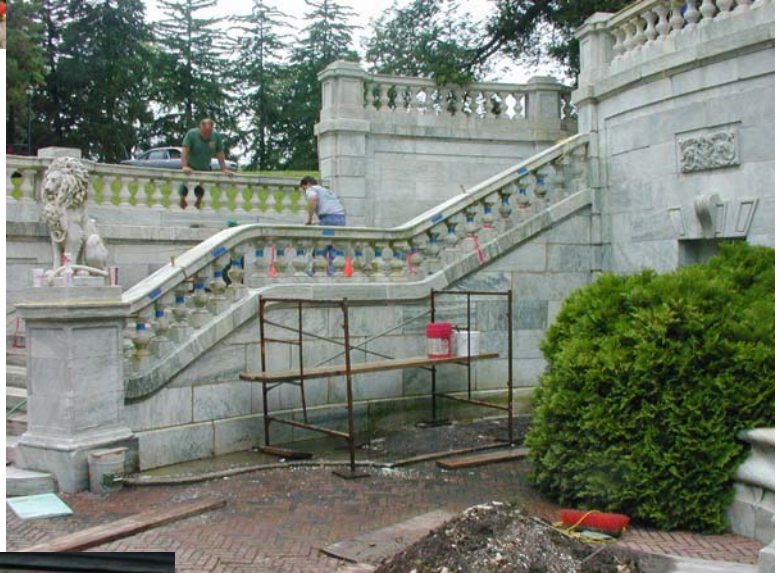
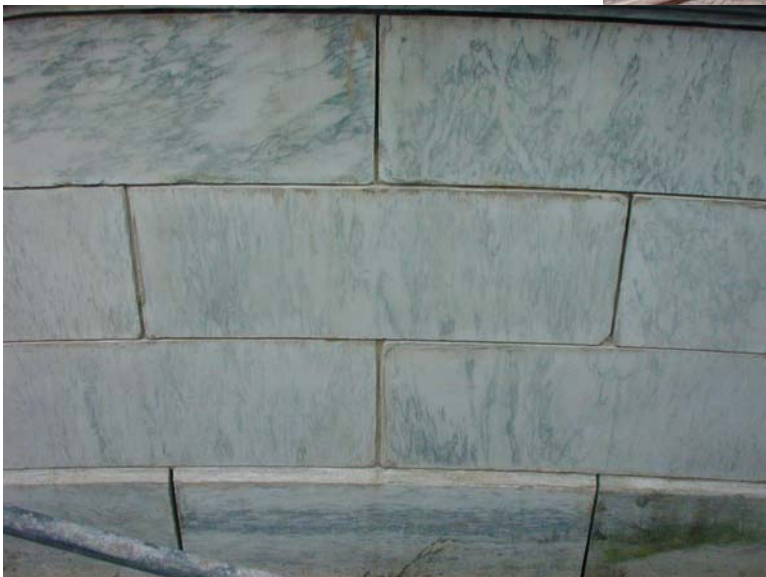
As mentioned earlier, previous repointing attempts had left a residue of hard Portland mortar, following the joints, and smeared across the face of the blocks. Because of the grooved texture applied as a finish to the stone neither hammer/chisel, nor grinder/sanders could be used to remove the material. As noted, a Dremel with shaped, heatless, ceramic wheels was used to carve away these unsightly deposits.

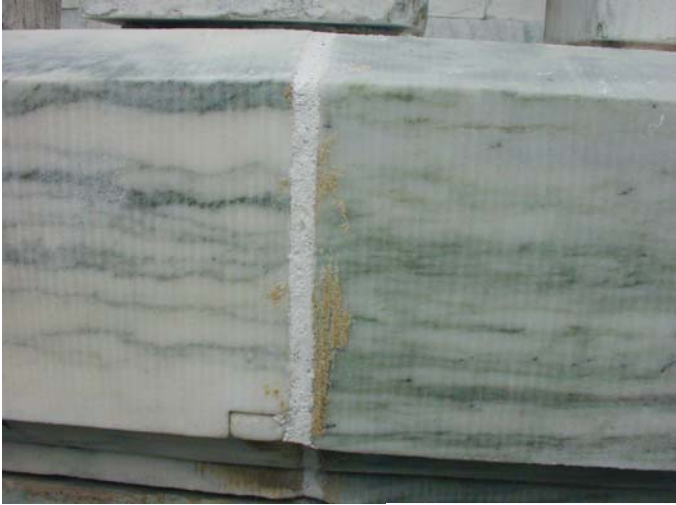
6) ...and again...

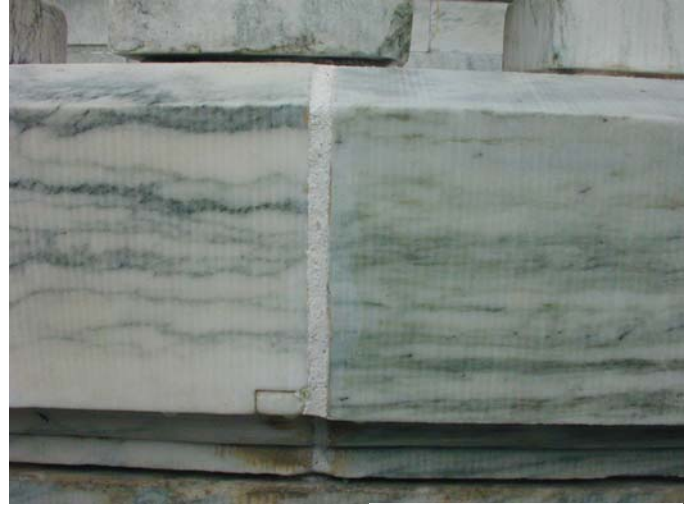
...and so, this...
