Porte Cochere

The morning of Jan 6th, 2003, it was noticed that the porte cochere at the main entrance to the mansion had been struck once again, and that this end section with the two columns it supports had been shifted further out of position.

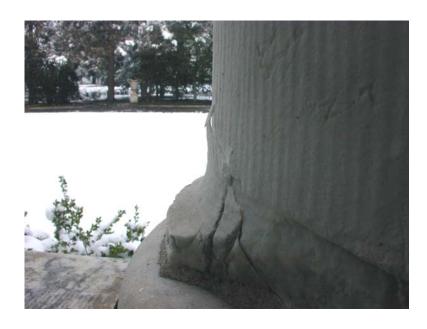
The photo to the right, presenting the opposite side of the column, shows the results of having the entire weight of the structure rest on a single point instead of shared out across the entire face of the base.

It will not be possible to realign the break without disassembling the columns, however, the old mortar will be removed prior to moving the marbles, and the gap will close somewhat in the process.

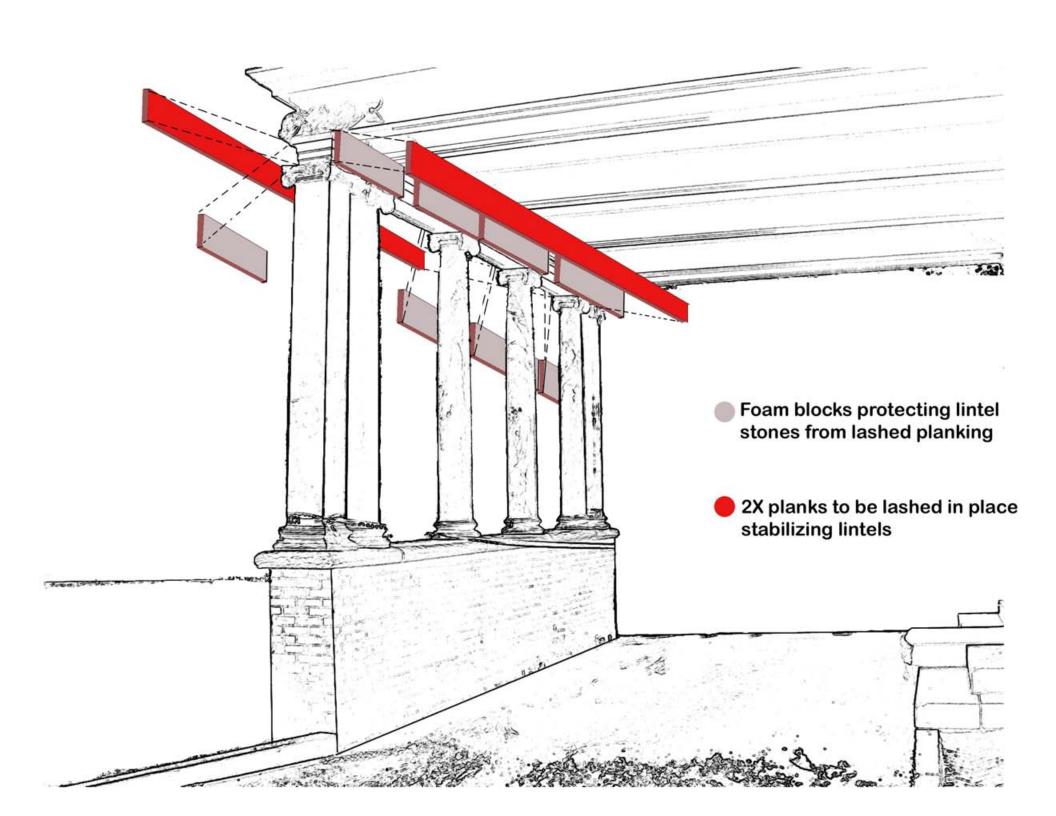
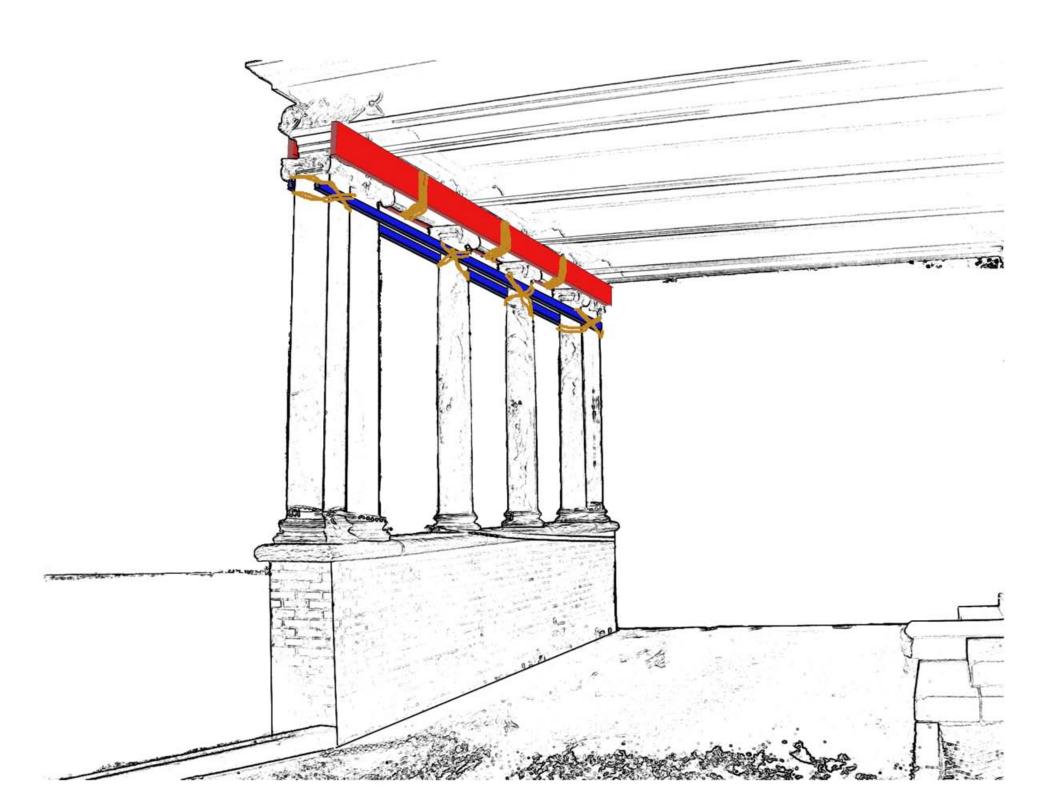
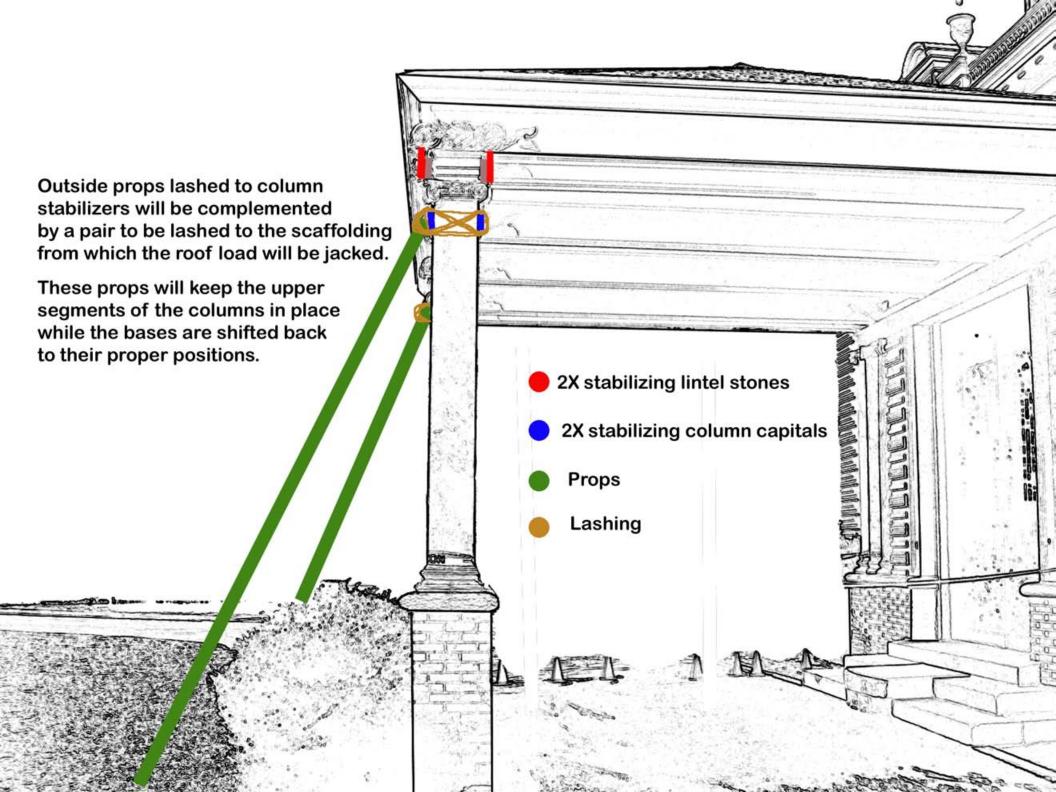
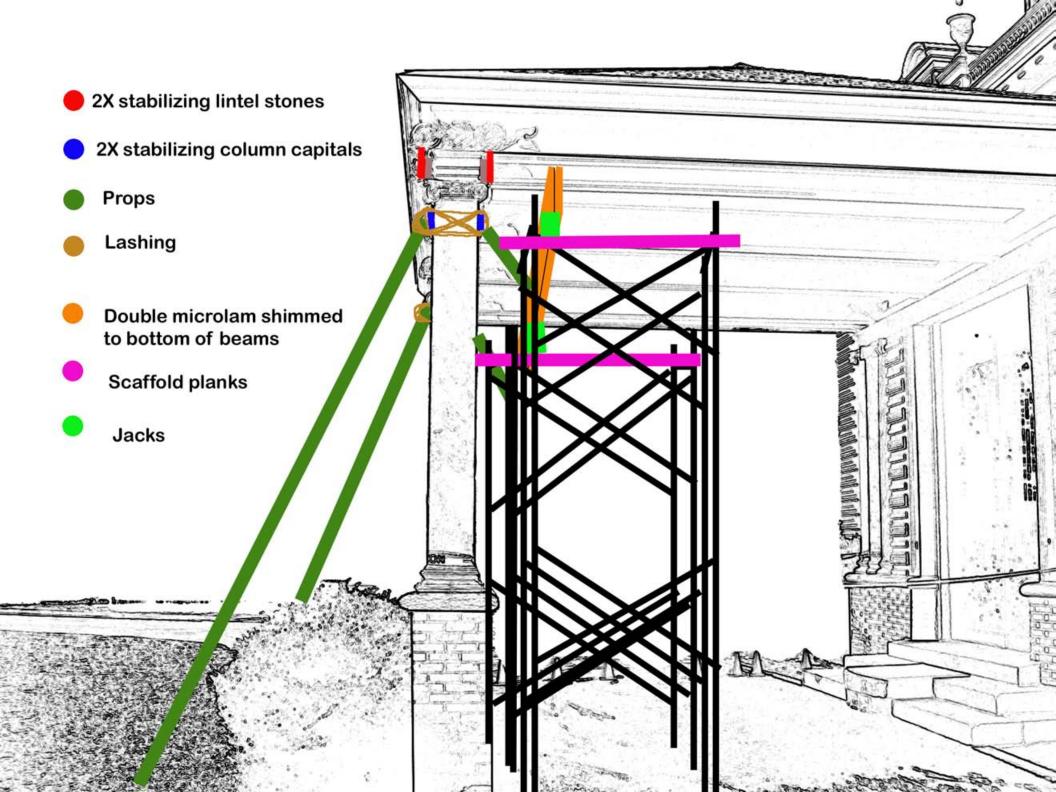
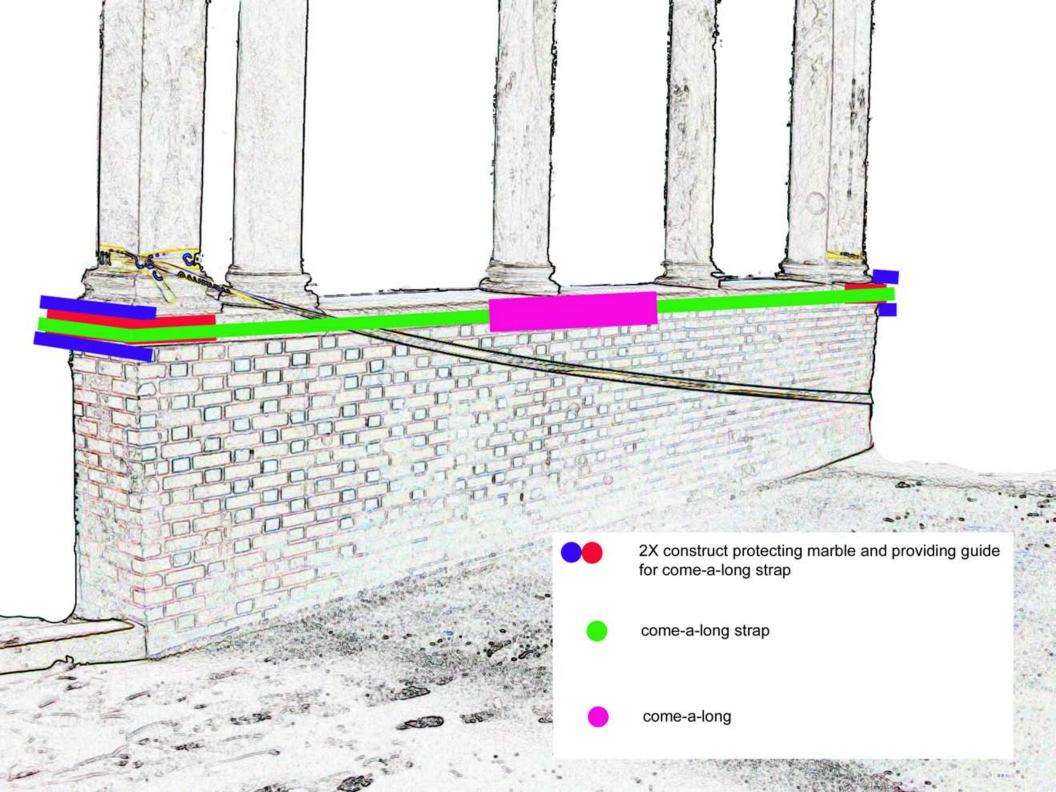
2X construct protecting marble and providing guide for come-a-long strap

The only significant changes made from the drawn plan were to move the mount for the jacks from the upper deck of the scaffold, to the ground, and the addition of scaffolding outside. The operation was a success.
